### **Monitoring Streambanks and Riparian Vegetation**

Multiple Indicator Monitoring

Ervin Cowley and Tim Burton

June 2004

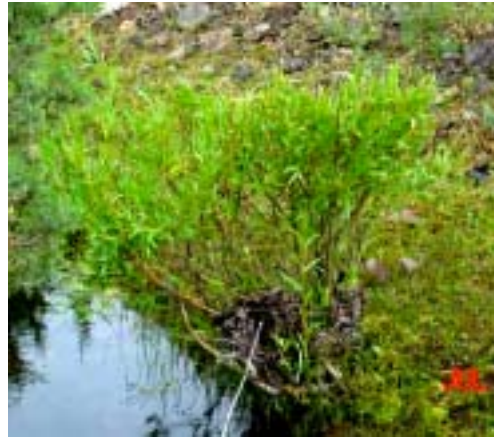
**Figure 3—Little or no hedging** – Two-year-old wood is relatively long and only slightly unaltered. Most riparian species grow with a strong central stem with annual growth from a terminal bud. The central stem is relatively unaltered.

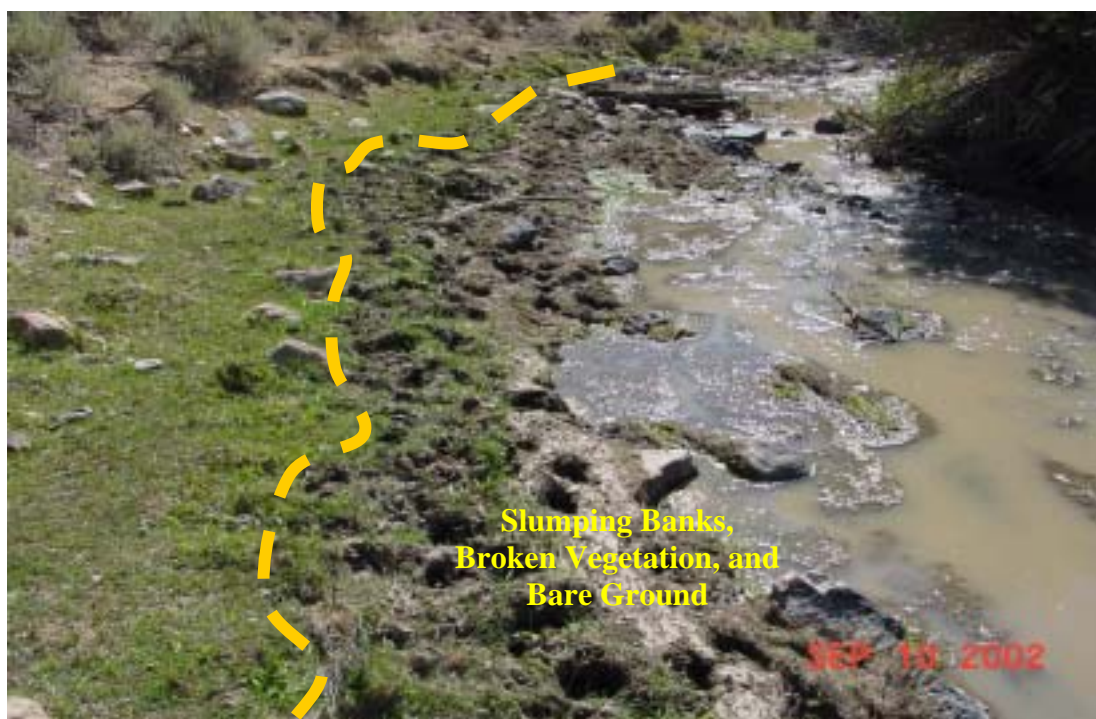
**Figure 7**—The greenline is along the dashed line. To the right of the dashed line is the relatively continuous stand of perennial vegetation (mostly Kentucky bluegrass). To the right of the dashed line is bare ground and broken vegetation cover.

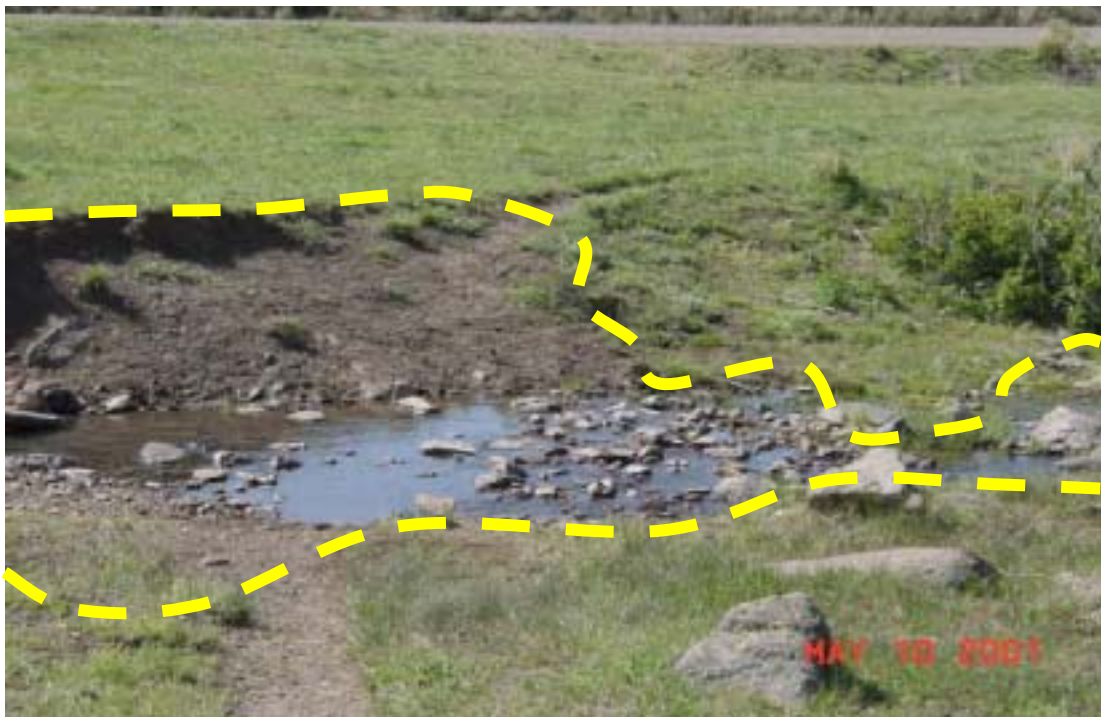
**Figure 11**—Greenline follows the vegetation line and crosses a livestock trail as a point where it narrows.

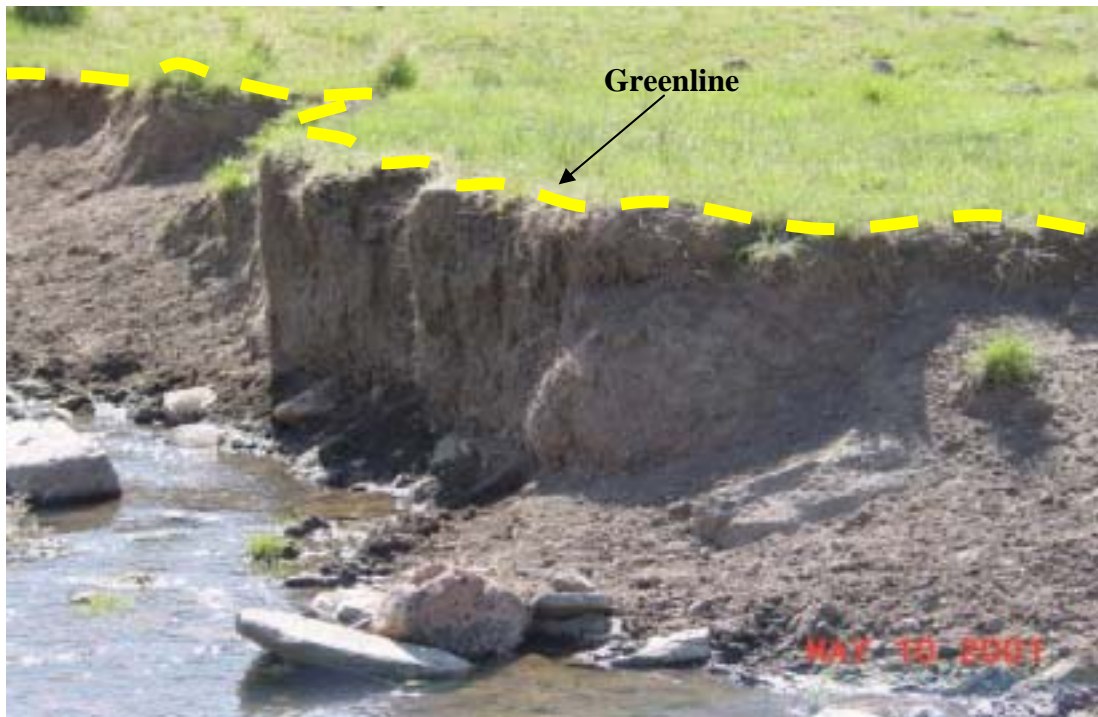
**Figure 12**—Greenline on a terrace with upland vegetation.

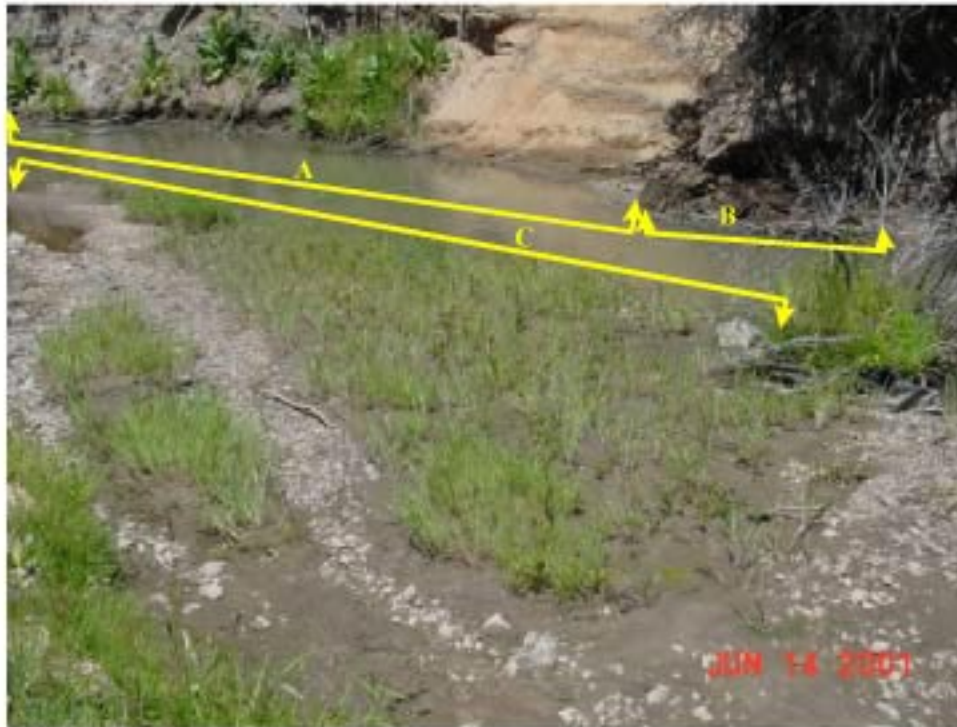
**Figure 3**—"A" is an erosional bank with little cover, uncovered/unstable (IIA 2a (2)(a)). "B" is an erosional bank composed of bedrock, covered/stable (IIA 2a (1)(a)). "C" is a depositional streambank with non-continuous, weak-rooted, perennial pioneering vegetation (*Alopecurus aquatilis*, short-awned oxtail), uncovered/unstable (IIA 1a (2))

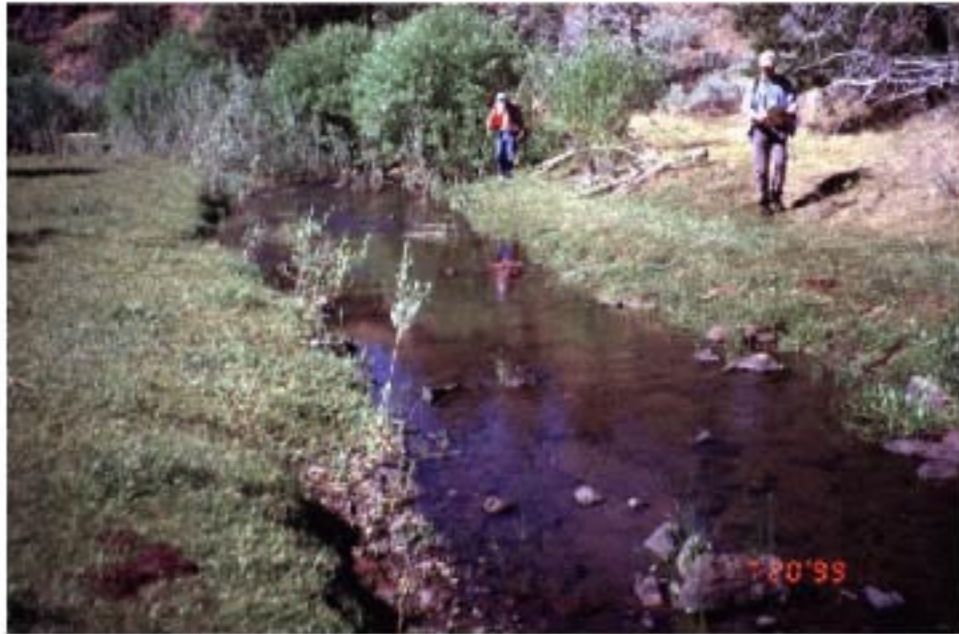
**Figure 5**--Streambanks covered with perennial sod-forming Kentucky bluegrass and low vigor Nebraska sedge and willows, covered/unstable (IIA 2a (1)(b)).

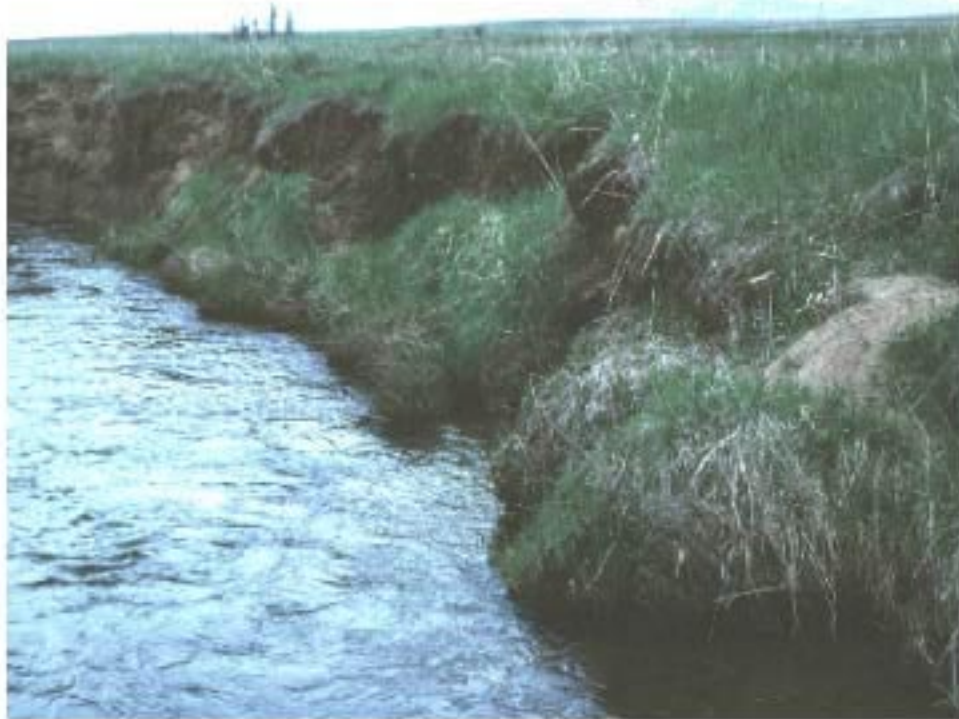
**Figure 6**--Slump blocks above the scour line. Vegetation on the blocks is upland and not considered deep-rooted. IIB 2b (2)

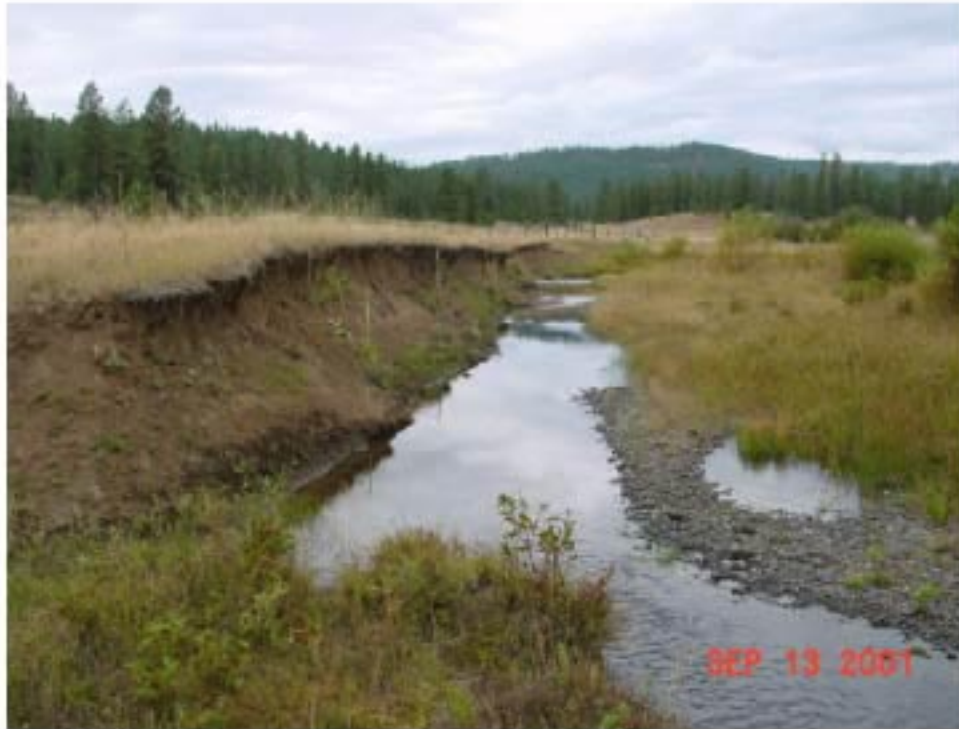
**Figure 7**–Left bank is not covered and the consolidated soil has resulted in a bank slope that is greater than 10 degrees from vertical, uncovered/stable ( IIA 2a (2)(b)). The right bank is covered with a continuous line of vigorous deep-rooted riparian vegetation, covered/stable (IIA 1b (a)).

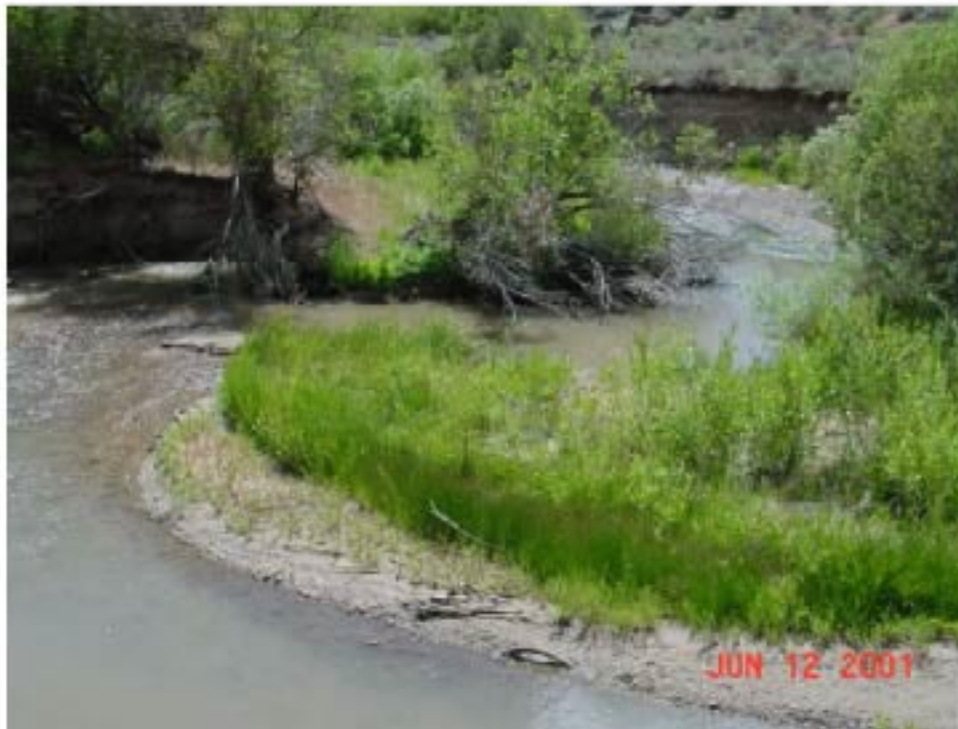
**Figure 8**–Point bar with continuous line of perennial deep-rooted vigorous vegetation at least one foot wide, covered/stable (IIB 1b (1)(a))

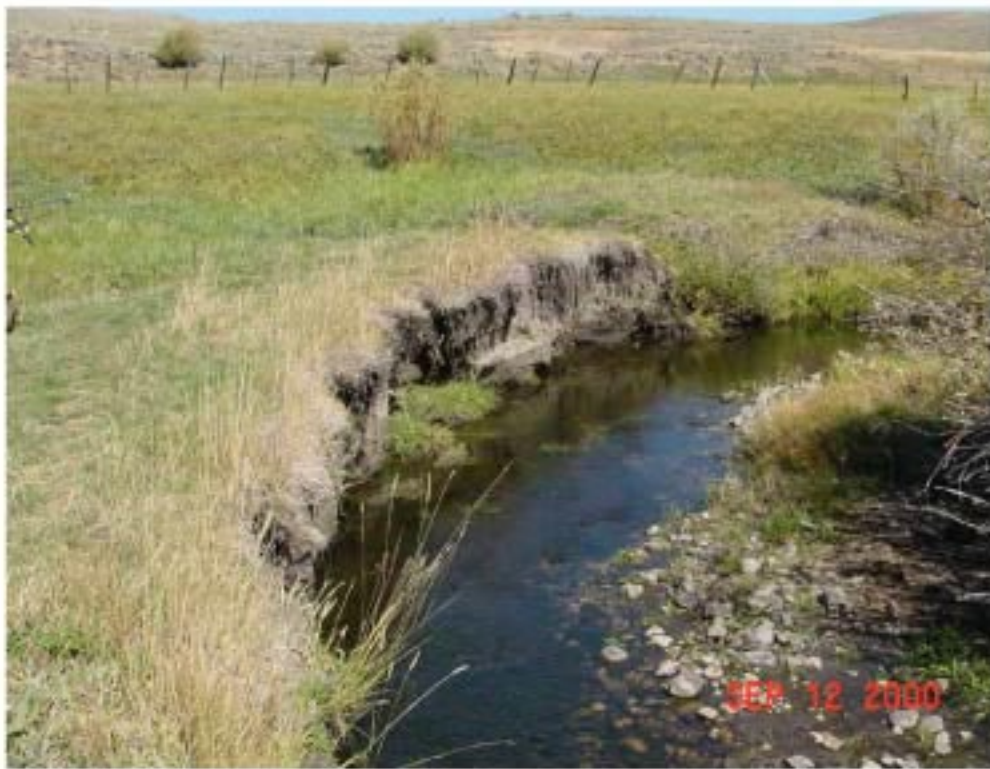
**Figure 9**—Slump block features below the scour line and not considered part of the streambank. Cracks or fractures are above the scour line, uncovered/unstable (IIA 2b (2)).

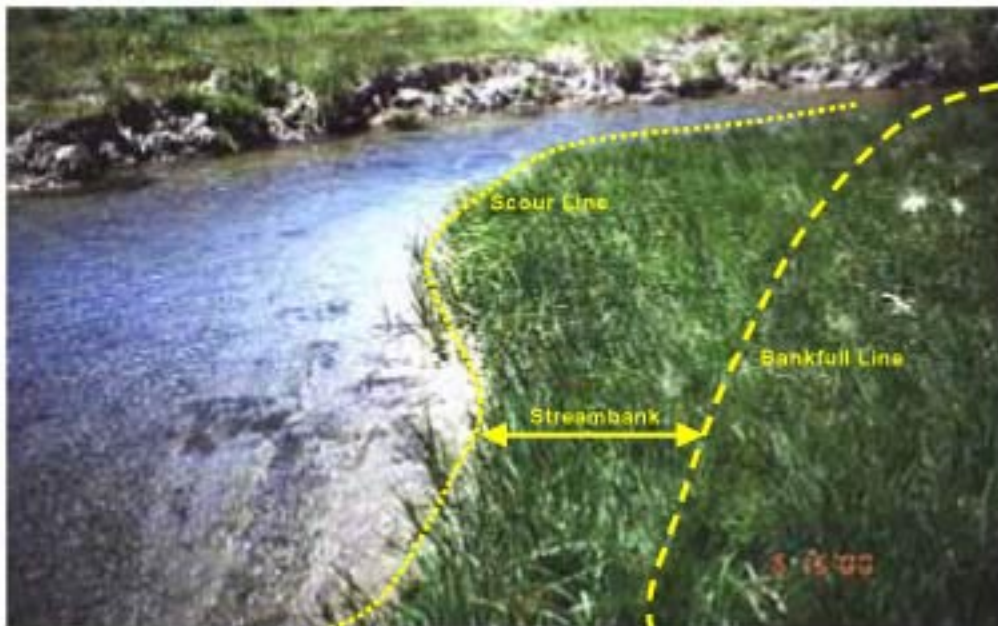
**Figure 10**—The streambank to be evaluated is between the scour line and the bankfull line. There a distinct change in the bank angle just below the bankfull line. This bank is covered/stable (CS), IIA 2a.

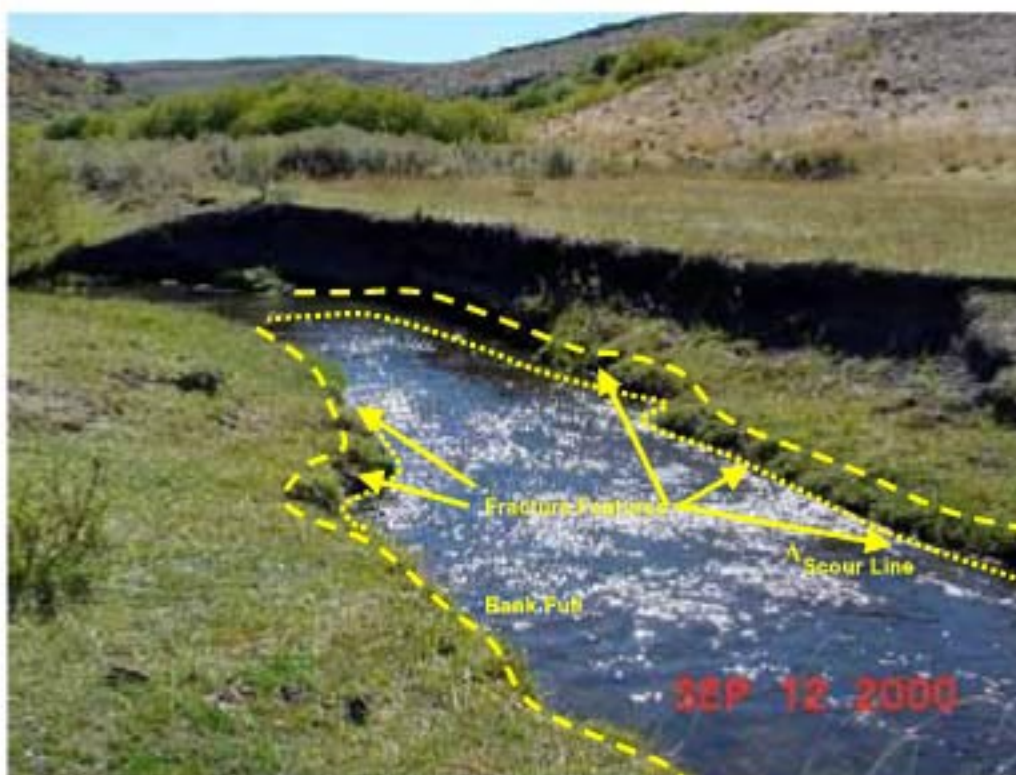
**Figure 11**—The scour line is at the base flow level. The streambank is between the scour line and the bankfull line. There are a number of fracture features along the stream. The streambank has fracture features with the slump blocks no longer attached. “A” is covered/unstable (CU), IIB 1a (1b).

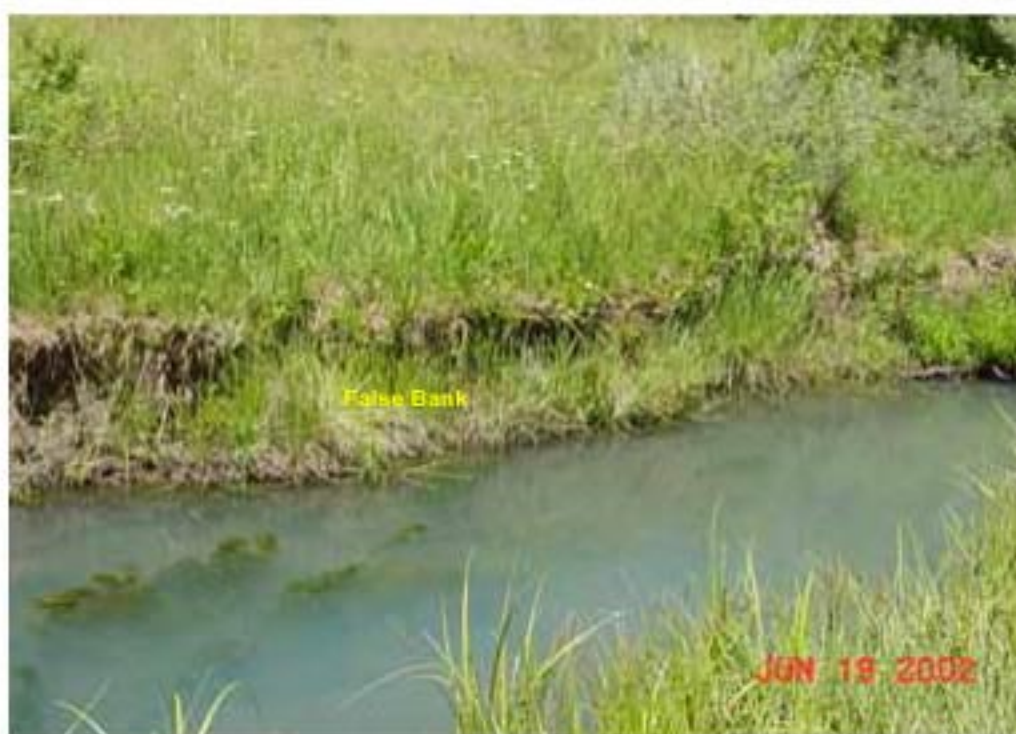
**Figure 12**—False bank is a slump block that is reattached and with vegetative cover.

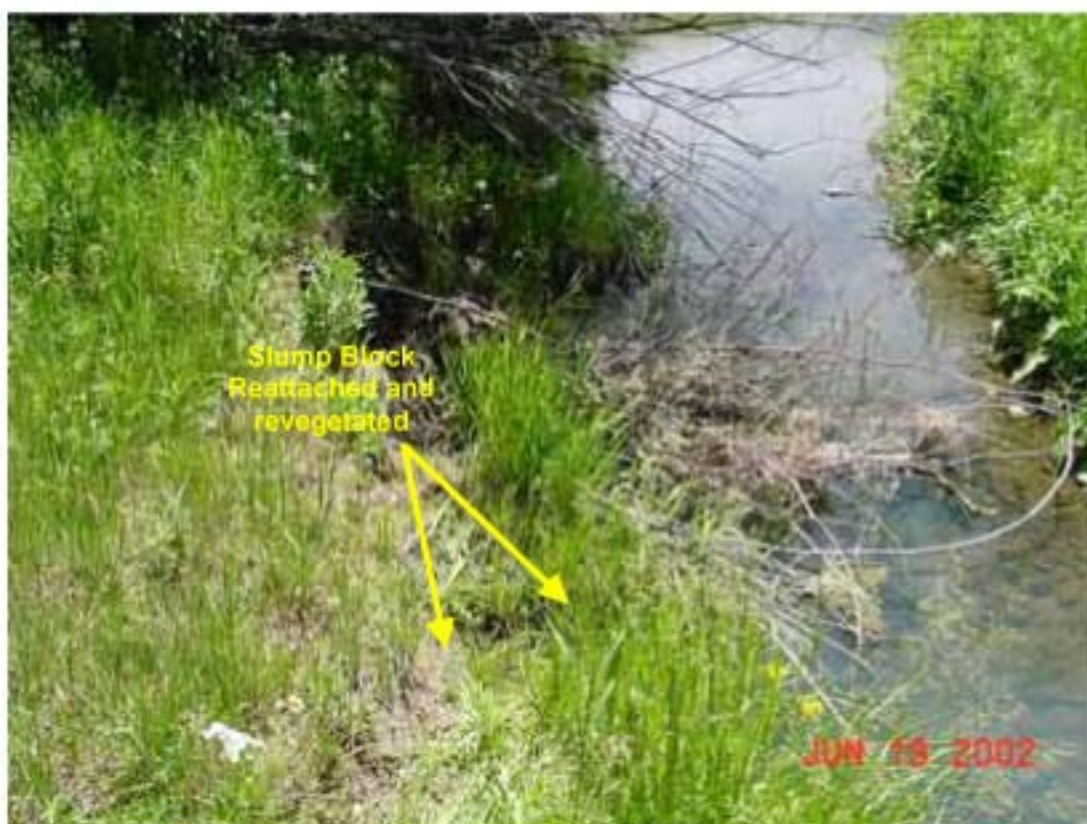
**Figure 13**—Slump block reattached and vegetated. It is classified as a false bank and is covered/stable CS.

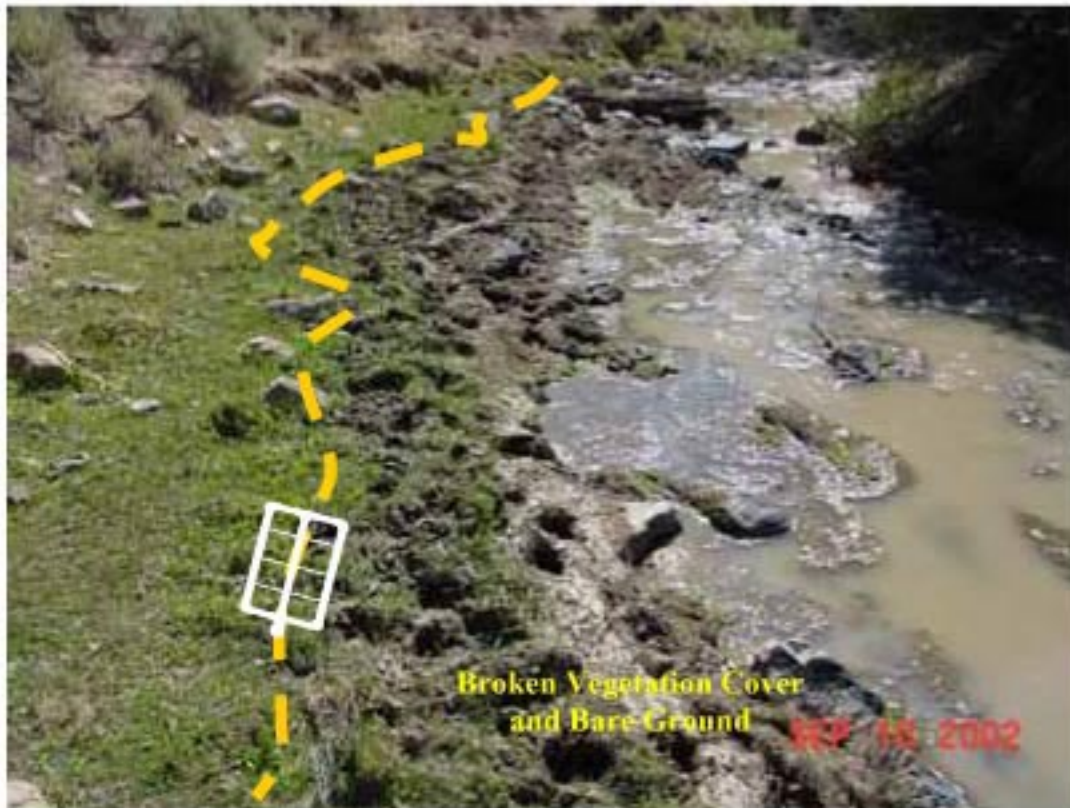
**Figure 1**—The greenline is along the orange dashed line. To the right of the dashed line is the relatively continuous stand of perennial vegetation (mostly Kentucky bluegrass). To the right of the dashed line is trampled bare ground and broken vegetation cover.

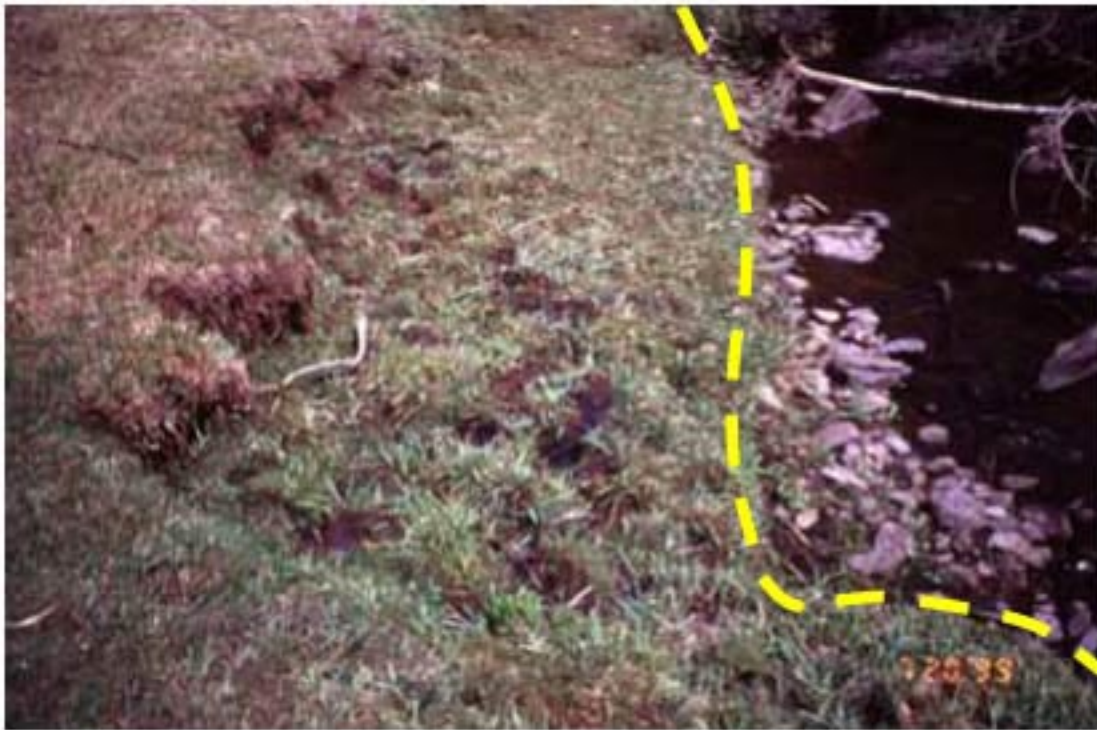
**Figure 2**—The greenline follows the dashed yellow line. The lineal grouping of perennial has over 50% vegetative cover.

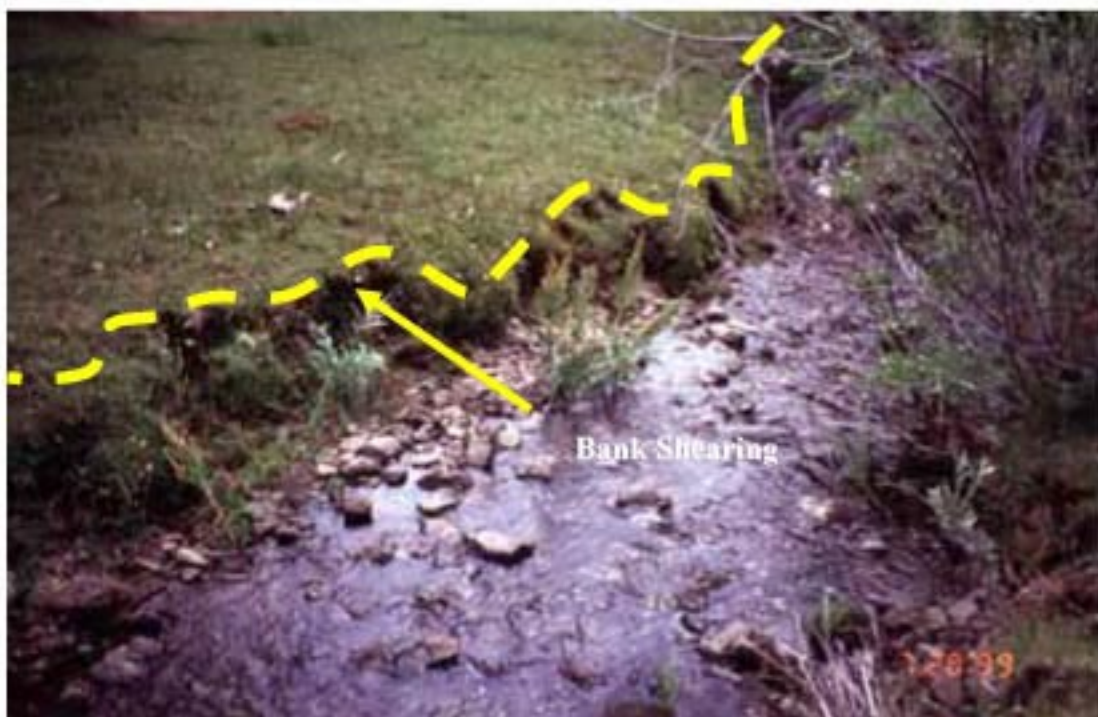
**Figure 3**—Greenline along an eroding streambank, shearing is evident.

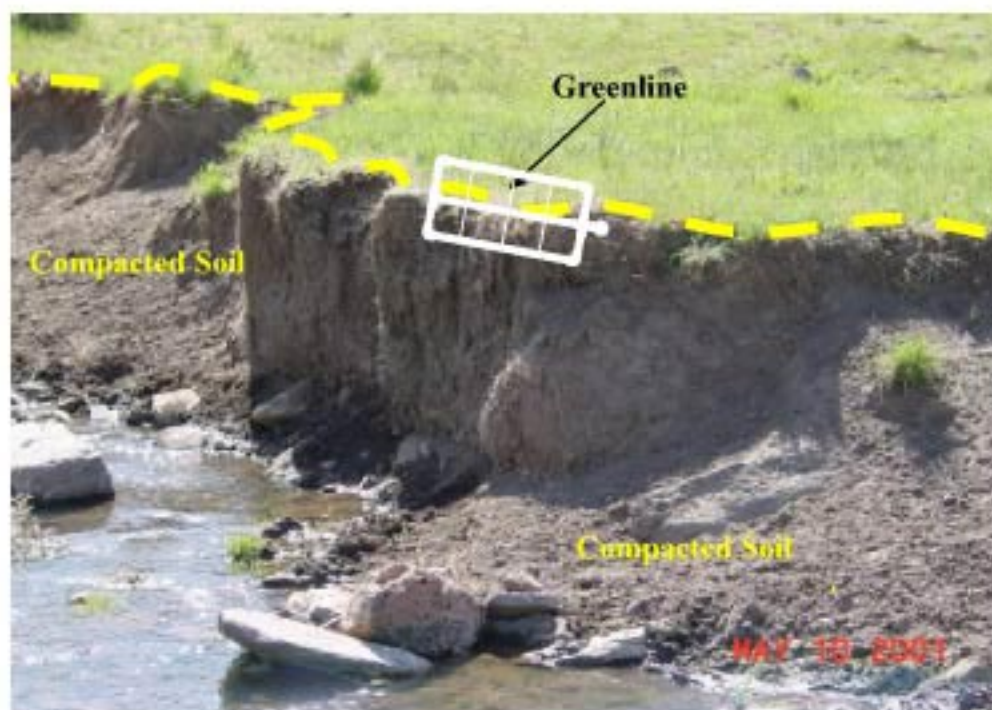
**Figure 5**—Trampling along the green line (dashed line). Note trampling along the base of the vertical terrace wall (arrows). Record as such.

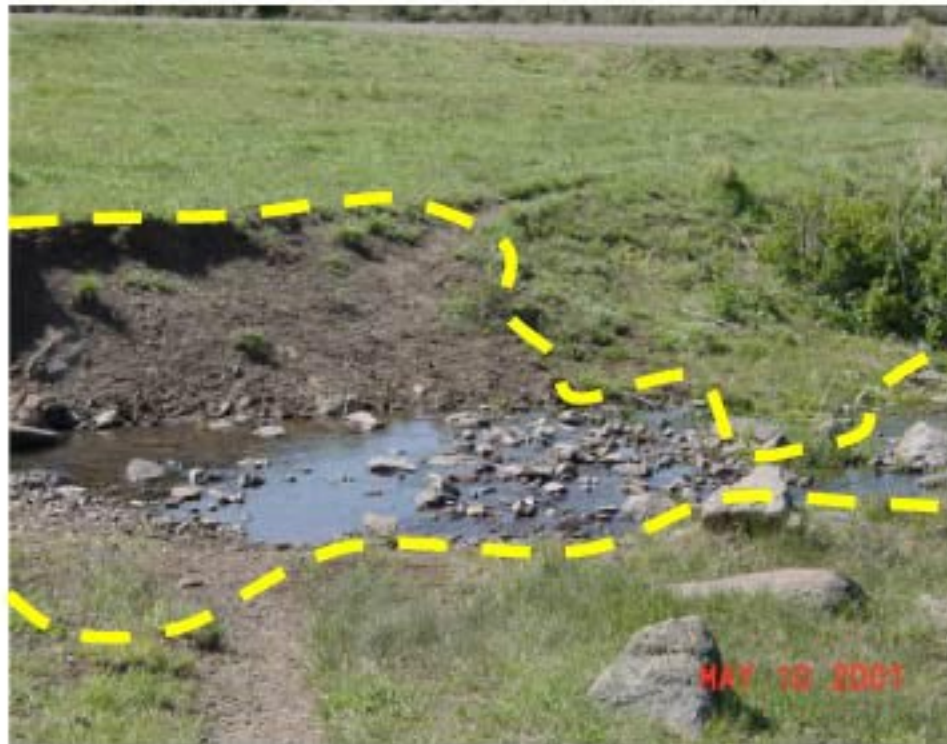
**Figure 6**—Livestock trail crossing the stream would be recorded as trampling even though the prints are less than  $\frac{1}{2}$  inch deep, due to compaction. Note the approximate bankfull line (dashed line).

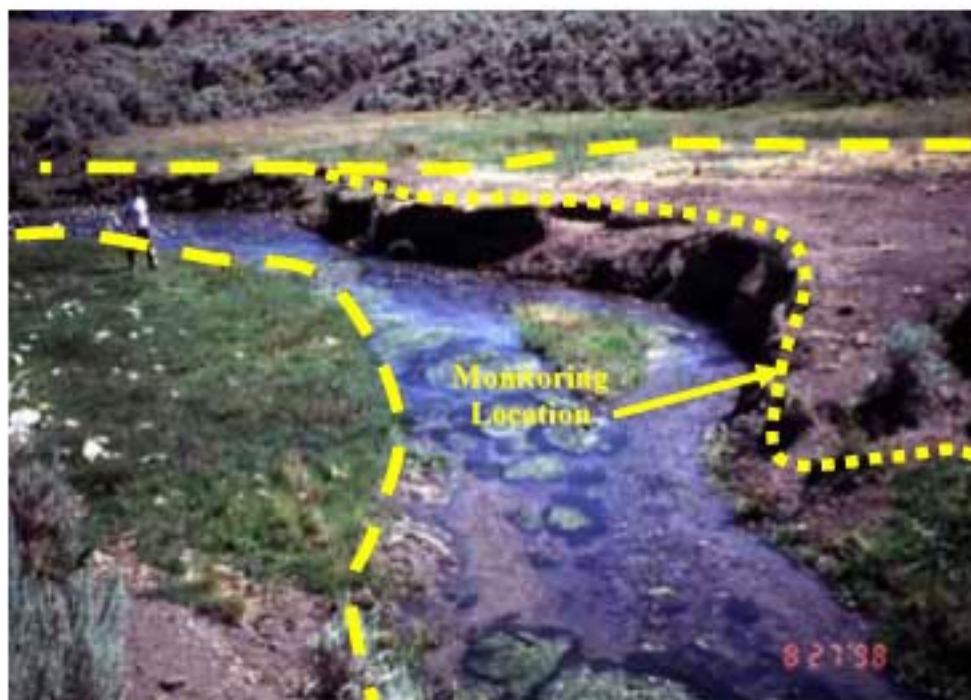
**Figure 7**—The greenline is located away from the streambank because only annual vegetation is located along the streambank. The fine dashed line shows the transect location.

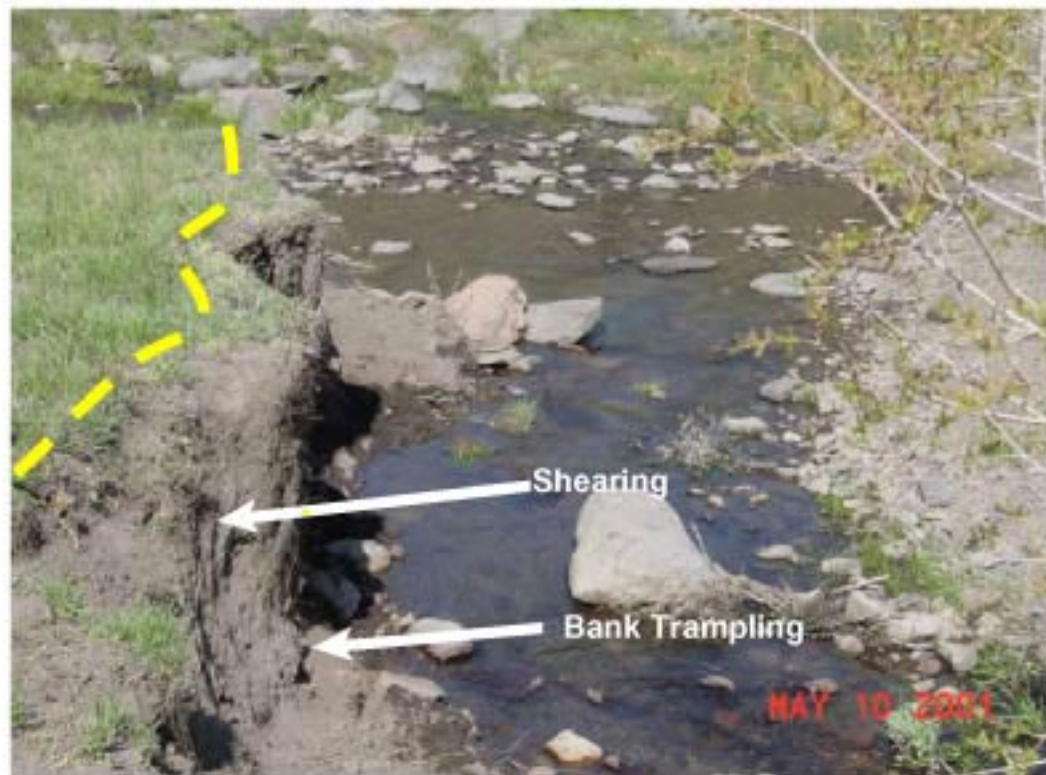
**Figure 8**—Shearing is along the terrace wall and bank trampling has occurred and is recorded as such.

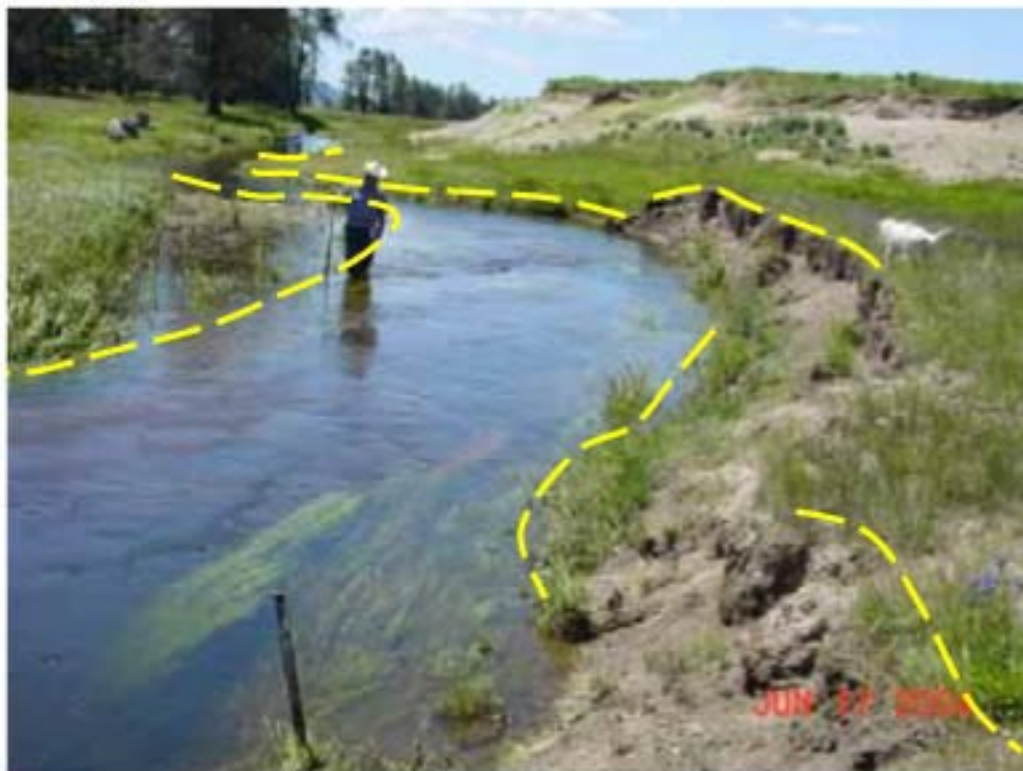
**Figure 9**—The greenline is below the water surface as the stream is above the base flow level. Note the greenline shifts from the terrace to the streambank where there is adequate vegetation

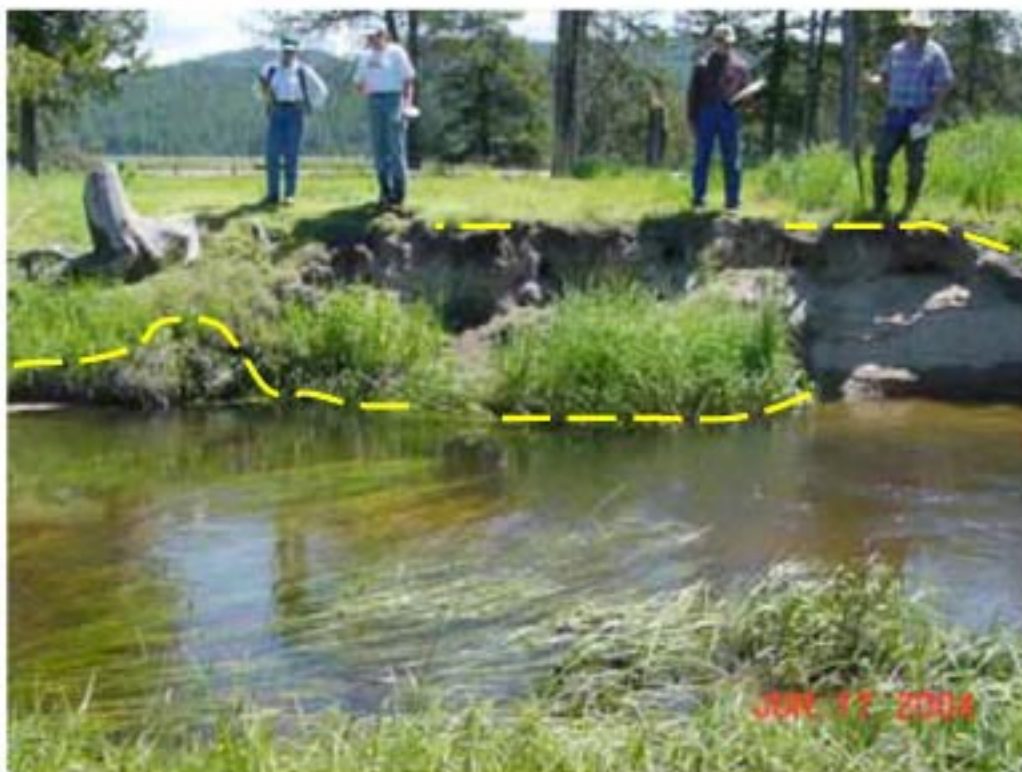
**Figure 10**—The water level is above bankfull, thus the greenline is in the water. Moving from right to left, the greenline follows the edge of the terrace until it reaches the vegetation along the water edge, it then shifts along the water's edge until it reaches the open area. It then shifts to back to the terrace, and then back to the water's edge.

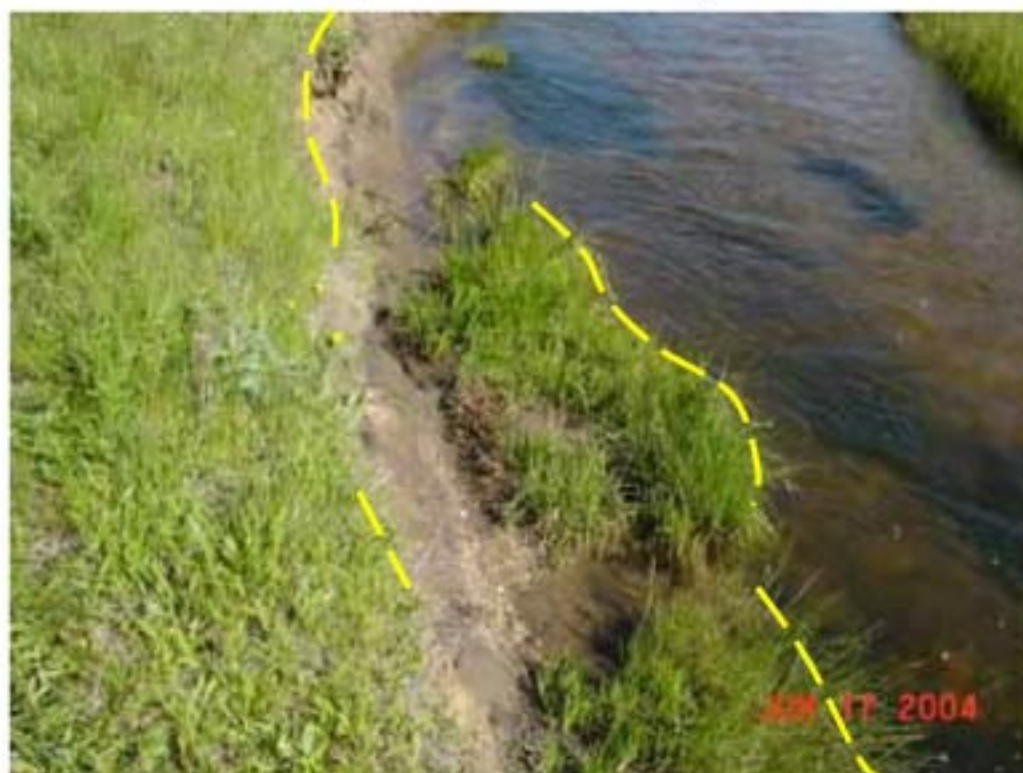
**Figure 11**—Vegetation along stream has more than 50% vegetation cover and area of at least 50% of the quadrant.

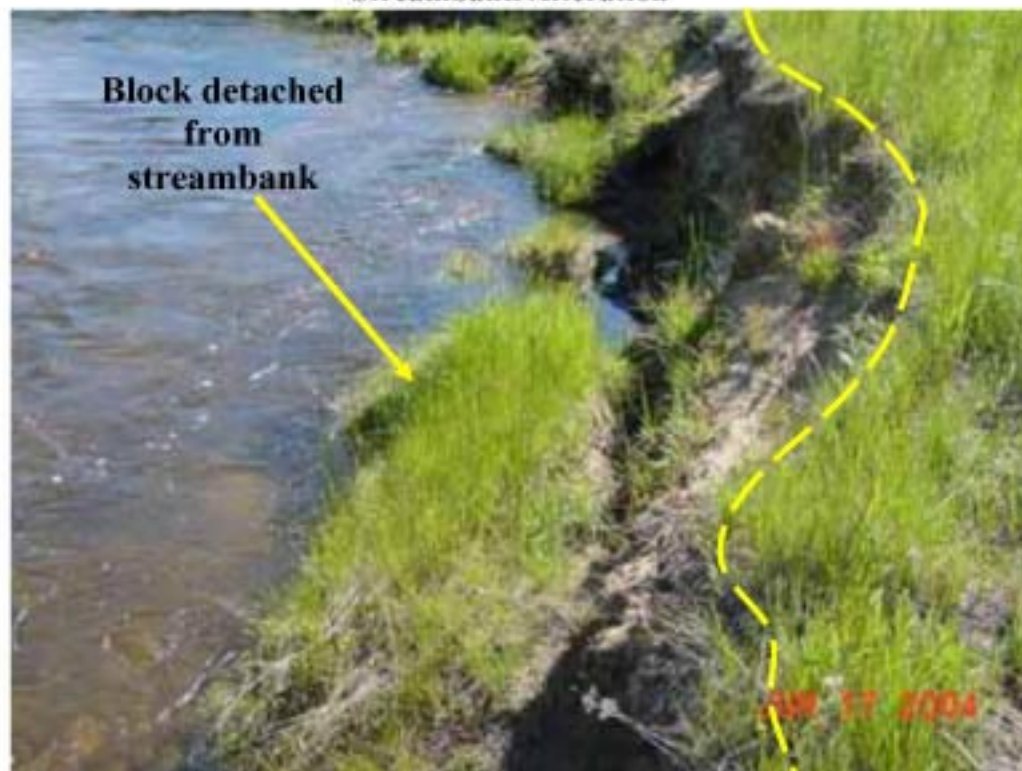
**Figure 12**—Slump block detached from the streambank. The greenline follows the line of perennial vegetation on the at the higher level.

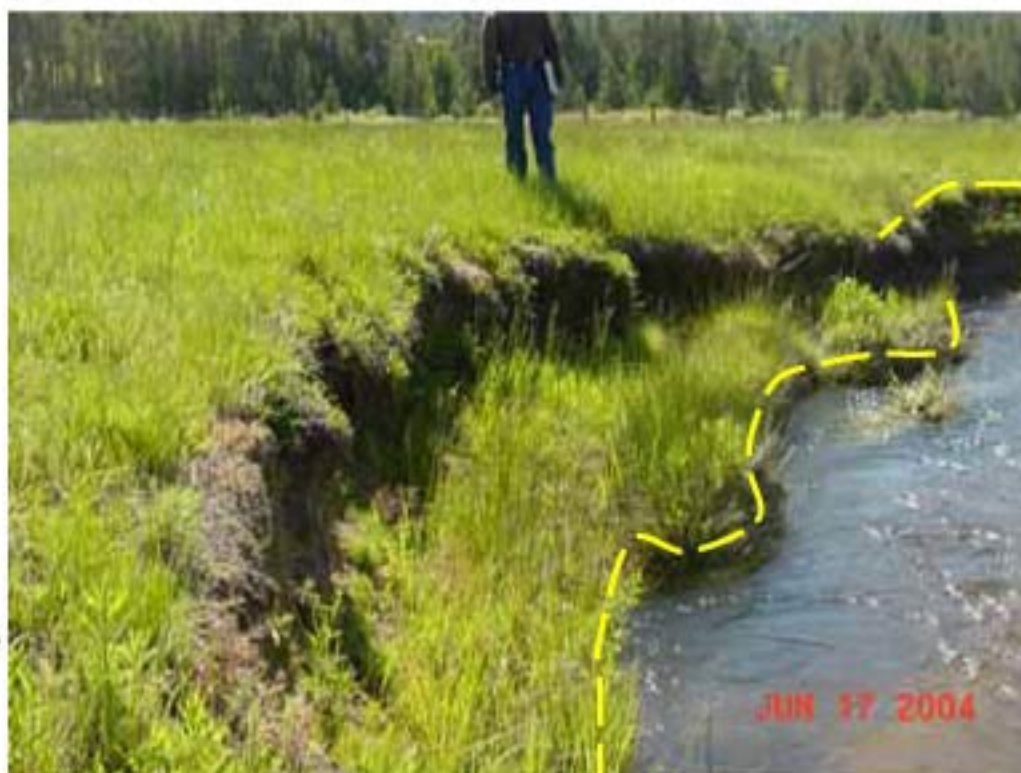
**Figure 13**—The slump feature is reattached the the streambank, thus the greenline is along the water's edge.

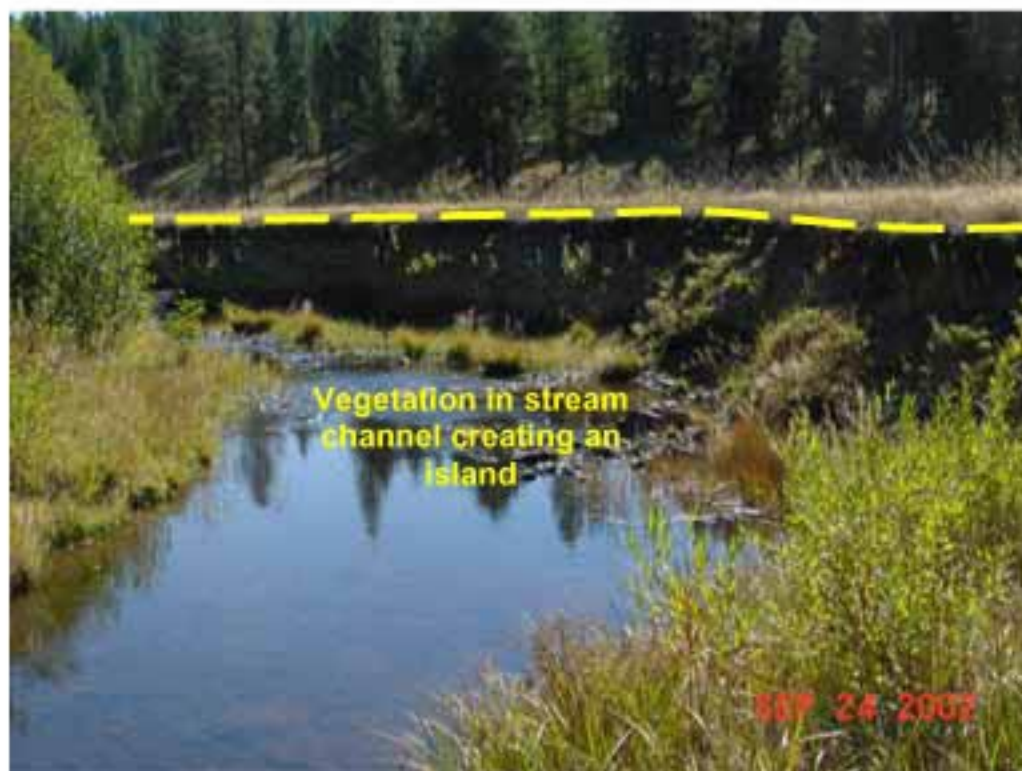
**Figure 15**—Vegetation in the stream channel is an island. The greenline remains at the edge of the terrace.

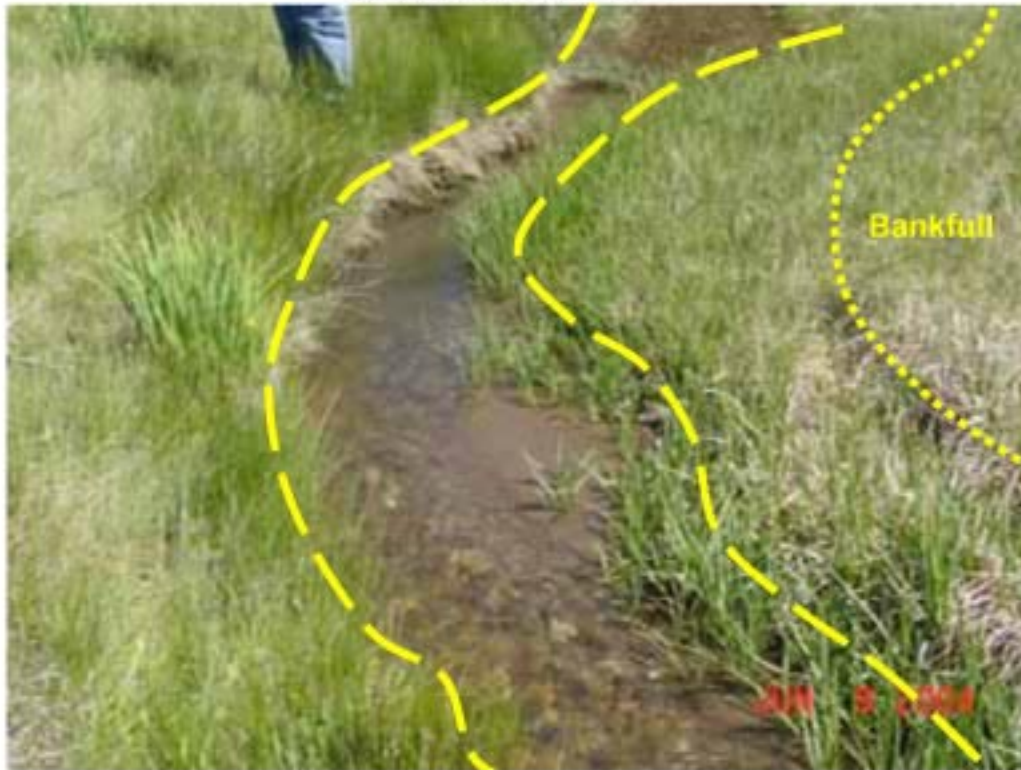
**Figure 16**—the greenline is near the water below bankfull narrowing the channel. The low water is a result of the drought conditions for past five years. Vegetation in the water is expanding from rhizomes and is less than 50% cover.

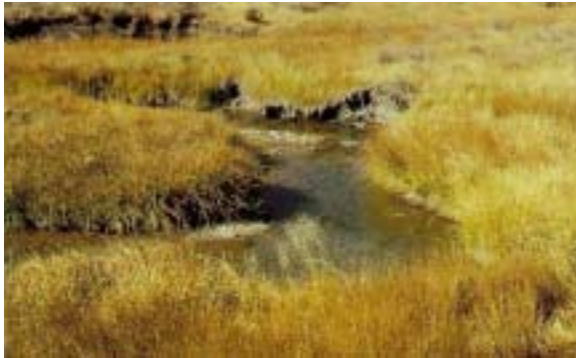
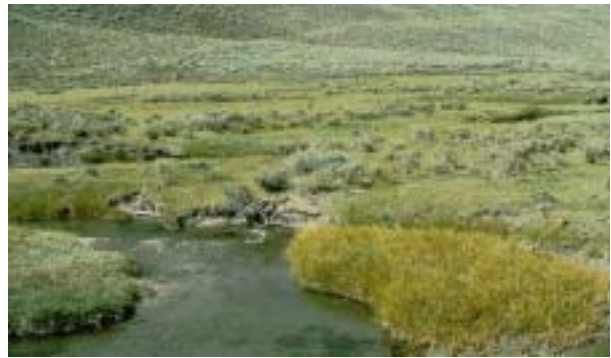
### I. “C” channel type, herbaceous vegetation dominant, potential vegetation: herbaceous or mixed herbaceous and shrubs.

- **TRIGGER: Within-season trigger to move livestock, to maintain or increase vigor on key hydric stabilizers:**
  - Stubble height on key riparian species, or species groups on the greenline
  - Use compliance (livestock numbers and time in pasture).
  - Bank disturbance or alteration
- **ENDPOINT: End-of-season indicator of proper use to maintain or ensure increased composition key hydric stabilizers:**
  - Stubble height on key riparian species, or species groups on the greenline
  - Bank disturbance or alteration
- **RIPARIAN OBJECTIVE: Long-term indicator of riparian condition to assess attainment of the Riparian Management Objectives**
  - Streambank stability
  - Greenline composition maintained or trend toward hydric stabilizers
